Analyst[®] TF 1.8.1 Software

Release Notes

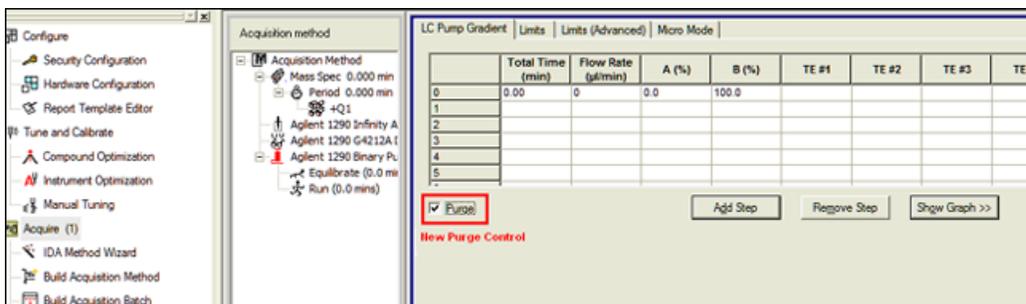
Figure 4-1 Purge Option in the Acquisition Method Editor

When the **Purge** option is activated, the Agilent 1290 Binary Pump opens the purge valve, allowing system purging.

To create a purging method, use only the **Total Time**, **Flow Rate**, and **A/B(%)** fields. Values entered in the Limits, Limits (Advanced), and Micro Mode tabs are ignored.

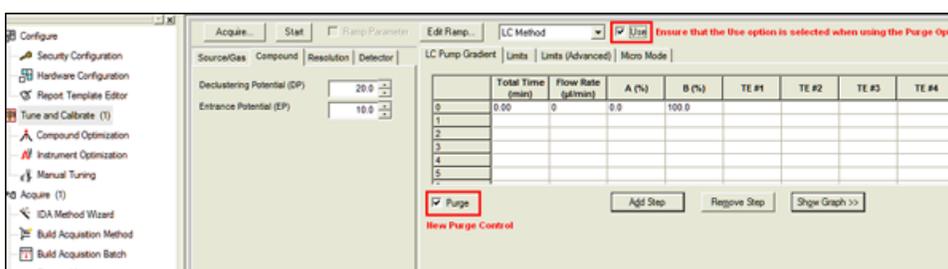
Figure 4-2 Purge Option in Manual Tuning

Use Manual Tuning to purge or prime the system or create an acquisition method to be used exclusively for purging. This method can be submitted via the Acquisition Batch Editor in the same manner as acquisition methods. In this scenario, the mass spectrometer acquires data to the specified wiff file.
